LIFE Multi Peat

Peatland restoration as part of the climate solution

European Peatland Policy Working Group

05.06.2024

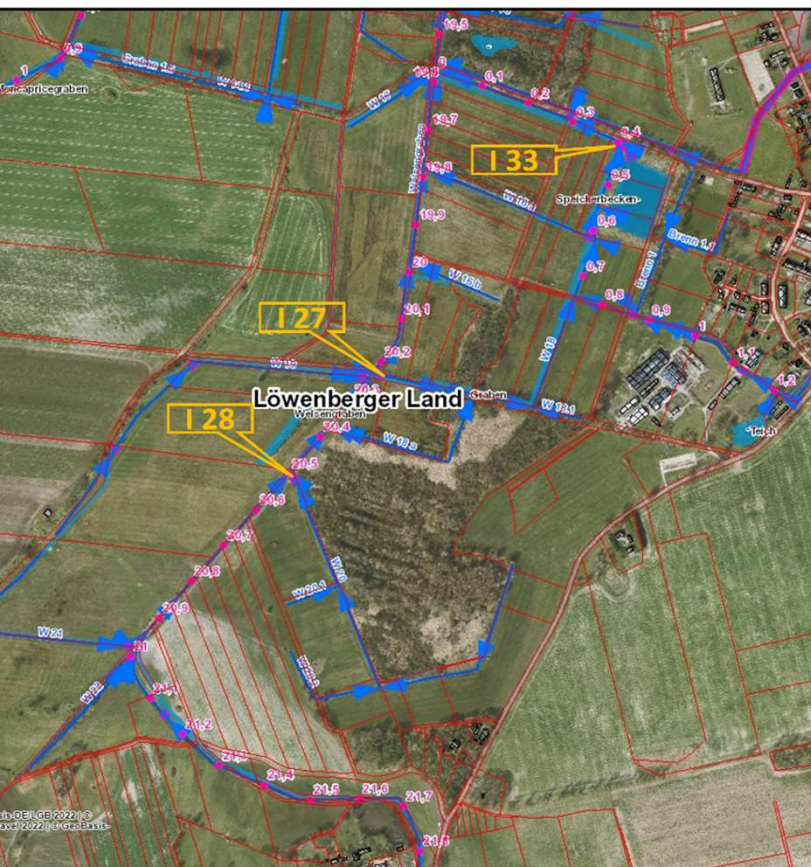
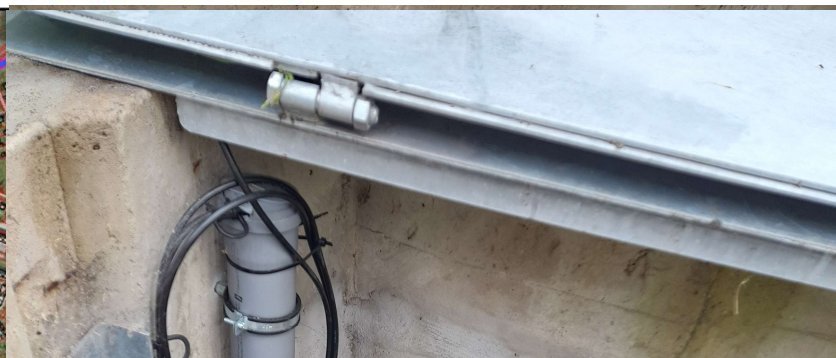
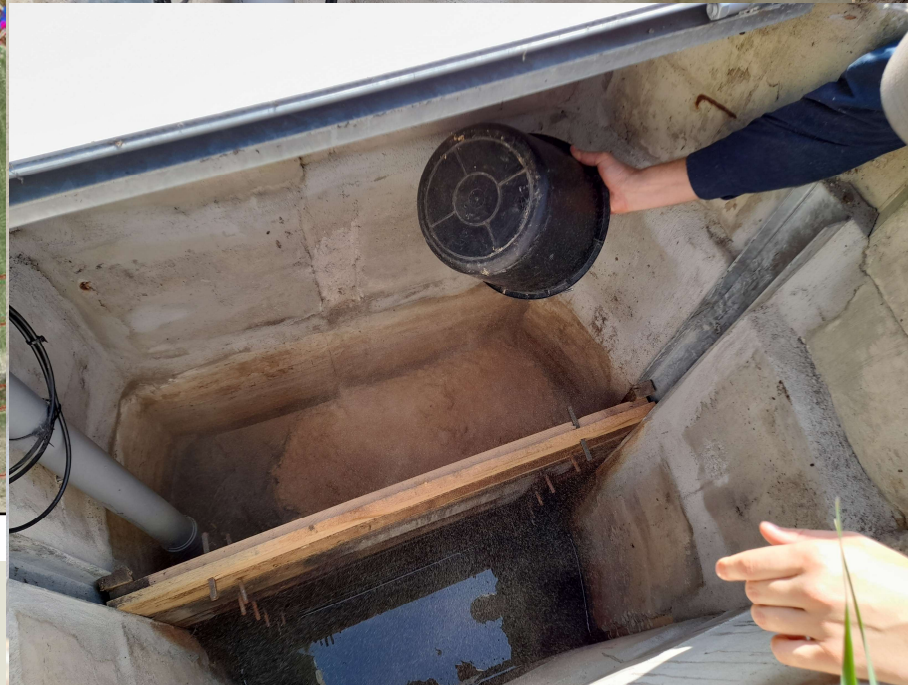
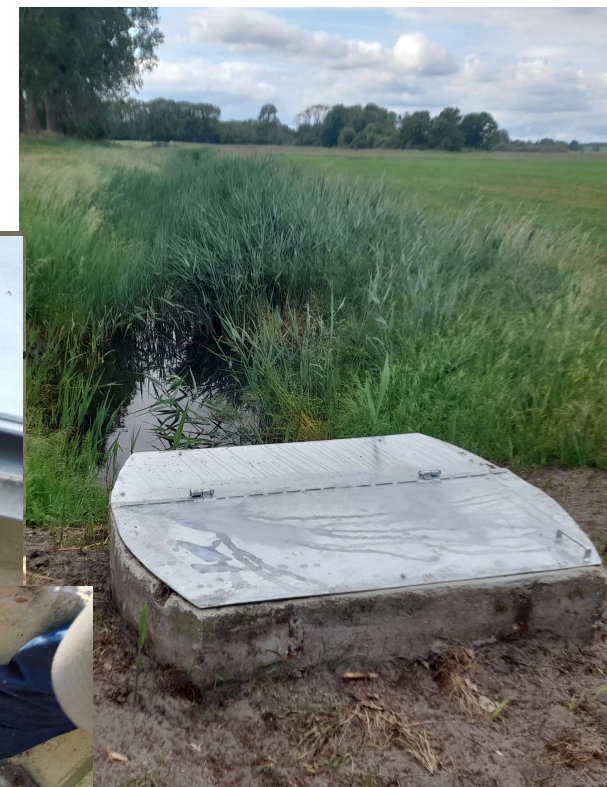
Repair of ditch regulating facilities, test rewetting for one year

- Tender
- Letters of consent 8 owners
- Planning, levelling by contractor
- Applying for permission
- Construction by water-soil-association 05/23
- Installing devices 06/23

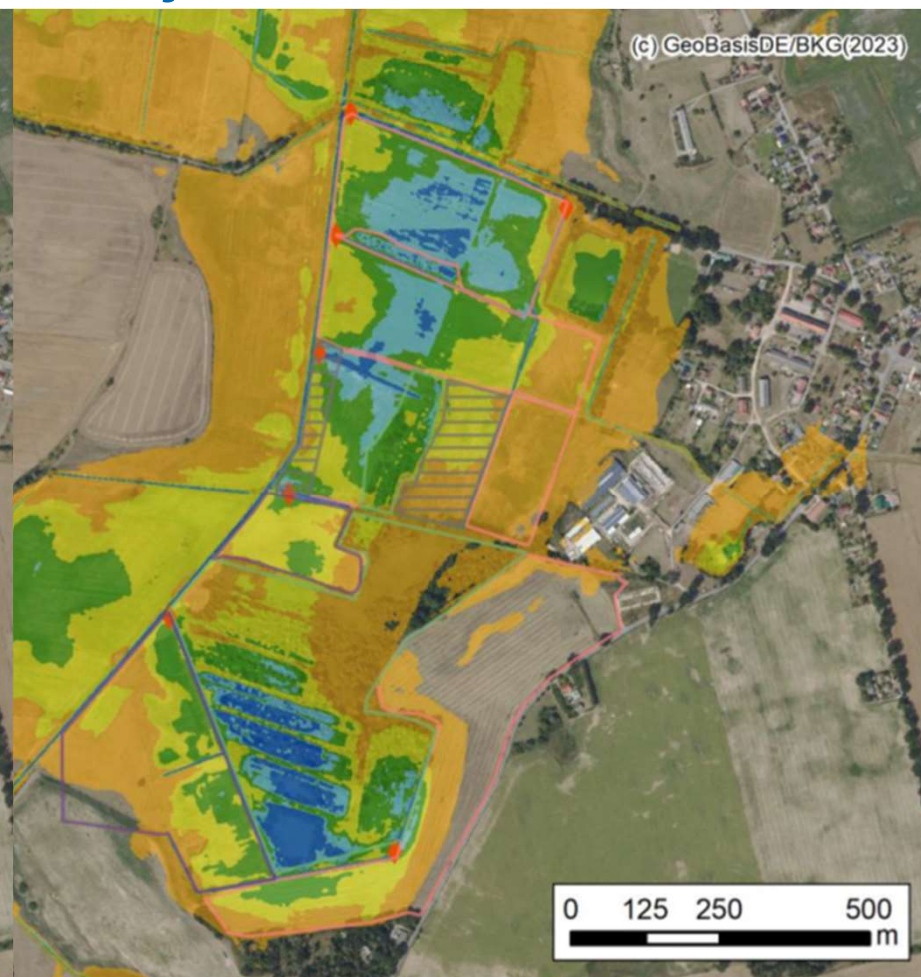
NABU-Compensation scheme „Klima +“: Water levels (Source: Biota)

Drainage state

Projected rewetted state

GHG-reduction potential:

300t/a

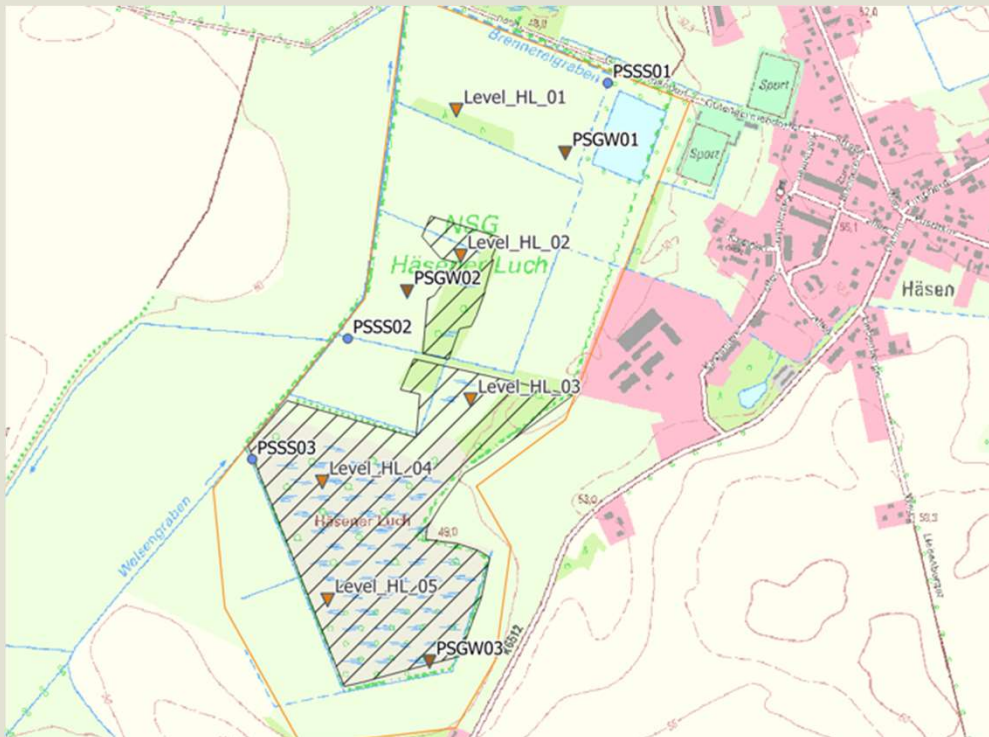
Hydrological Monitoring

- Monitoring of GW-Level at 5 plots since Oct. 22
- Installation of 6 additional GW-Sensors within the water flow test since Jun. 23
- Cloud-based solution and monthly based export and transfer of daily mean values to the lower water authority

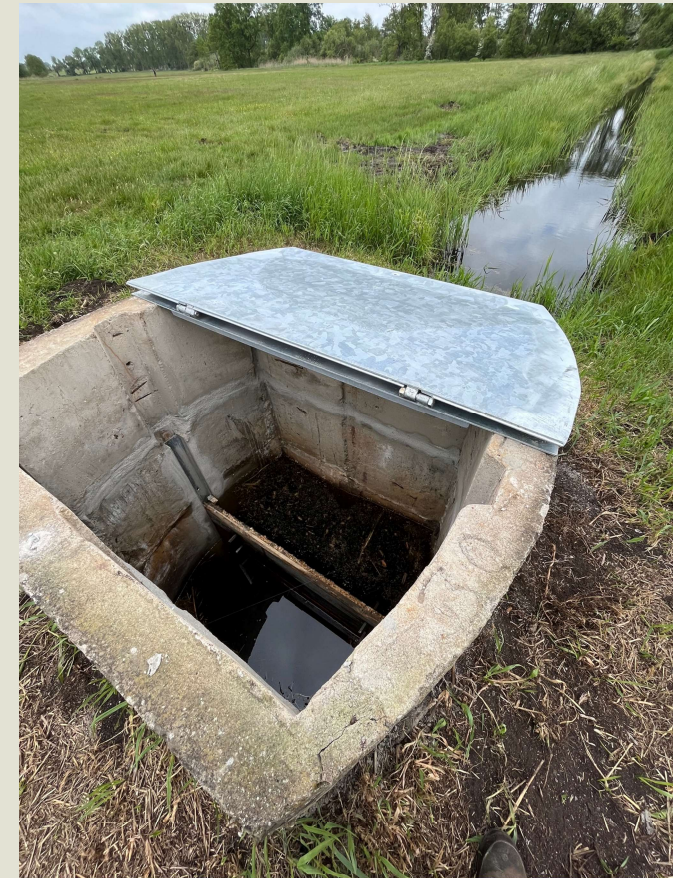
Hydrological Monitoring

Test rewetting by re-activating three old ditch regulation facilities (Schachtstaue)

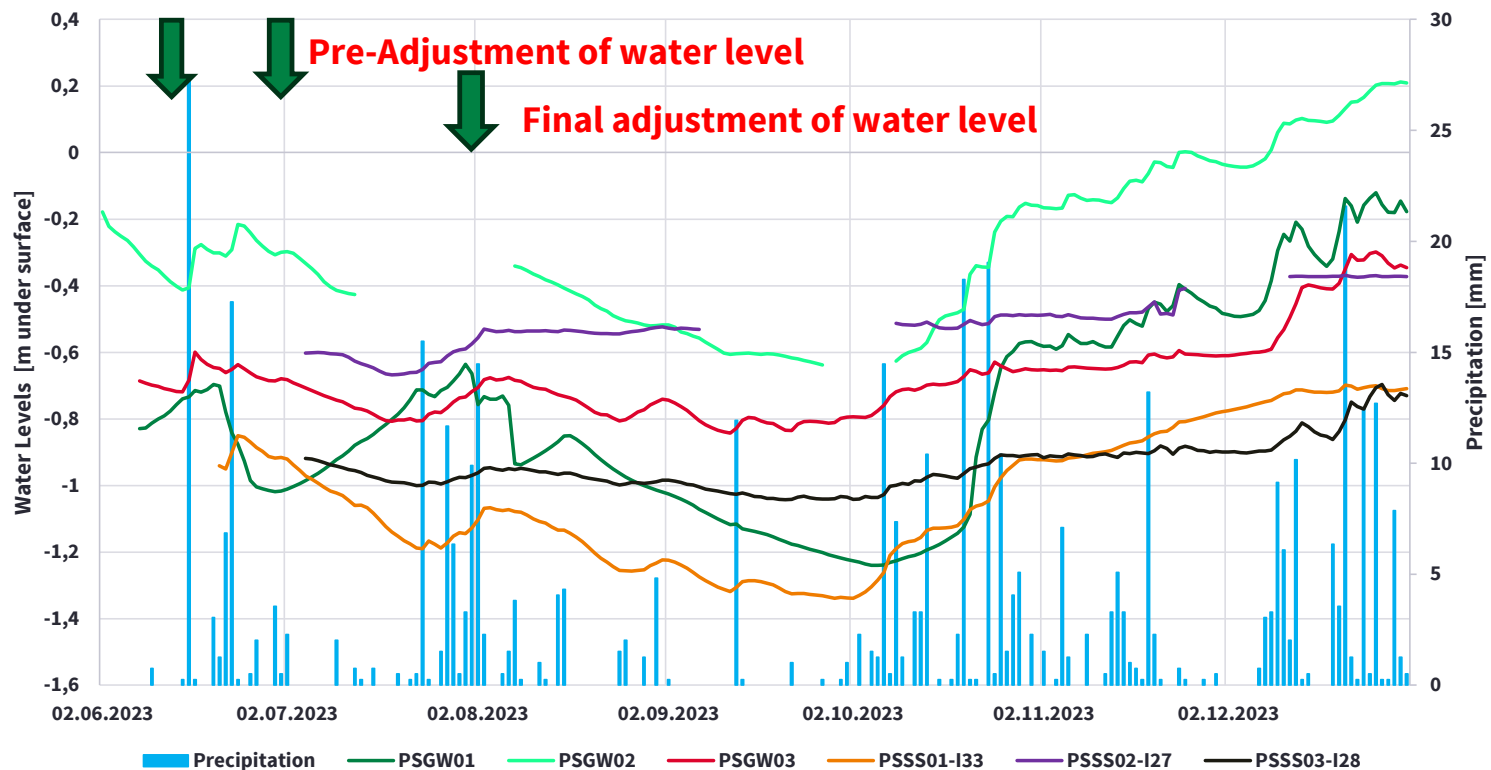
Test-Rewetting Häsener Luch

- PSSS01 and PSSS03 reached the planned water levels
- Effects must be evaluated throughout spring
- We try to get a information on sub-surface drainage systems

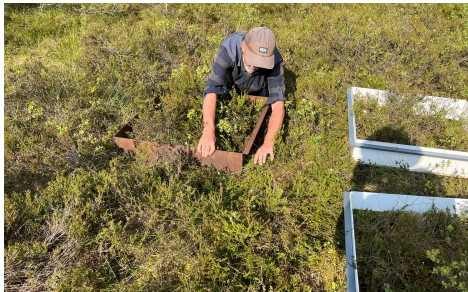
In each country three sites (drained, rewetted, restored).

Installation of 3 plots per site in Poland and 5 plots in Germany

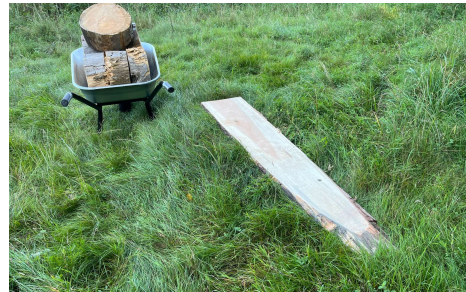
Installation of wooden boardwalks around the plots

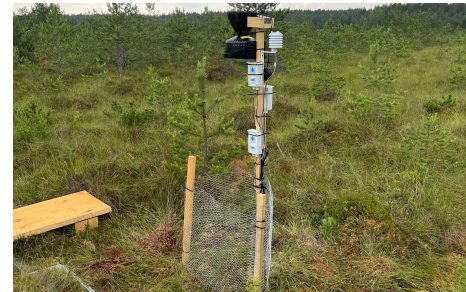
Installation of PAR, soil and air temperature sensors as well as rain gauge sampler with cloud support for all three Polish sites

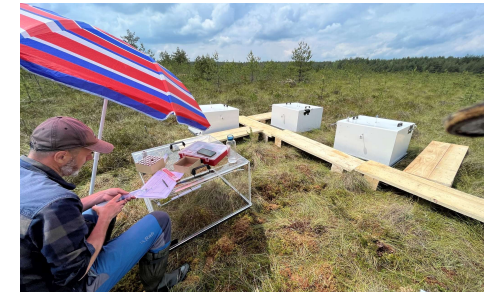
Starting Measurements in June 2023 in Poland with combined transparent and opaque chambers, CO₂ measured by LI-COR 810 and CH₄ by manual sampling

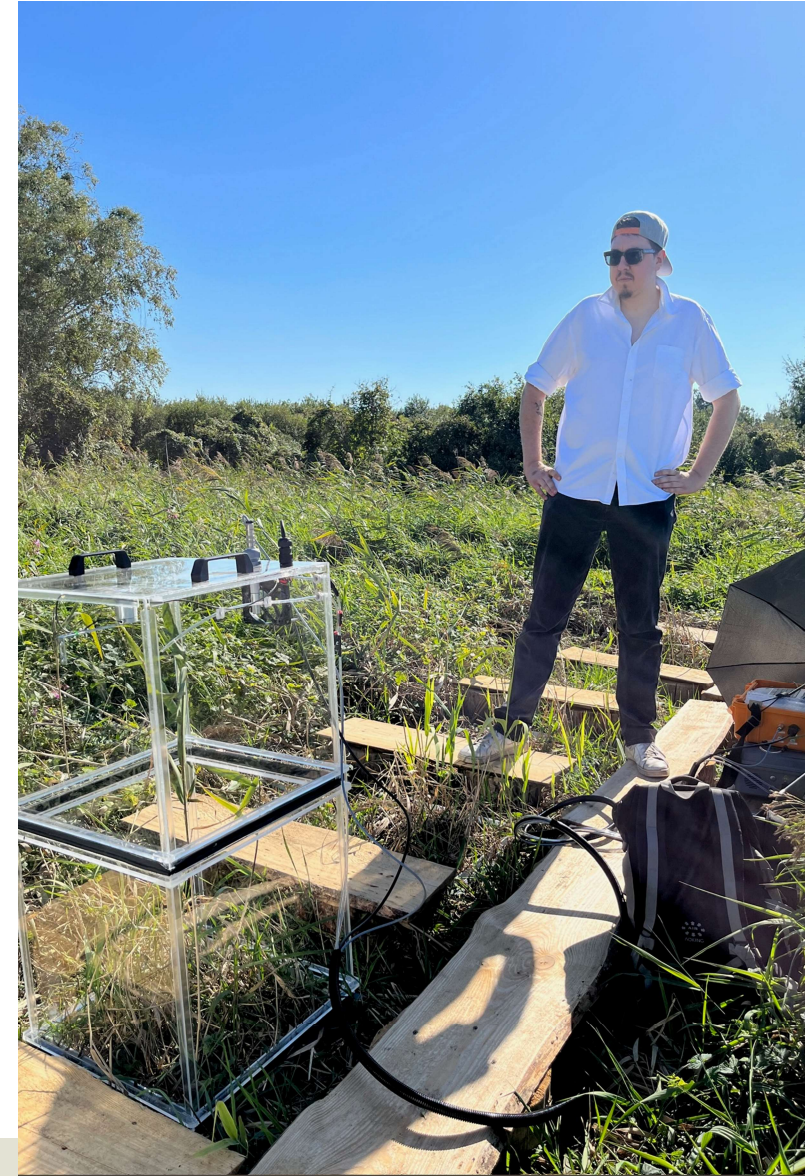
GHG Monitoring - Germany

- Measurements started mid of september 2023 at all three sites (drained, rewetted, restored)
- Combination of transparent and opaque chambers with different shading levels
- Insitu measurements of CO₂ and CH₄ with LiCOR 7810
