# LIFE Multi Peat

LIFE20 CCM/DE/001802

## Annual Monitoring Report (Actions D.1 & D.2)

(January 2025 - December 2025)

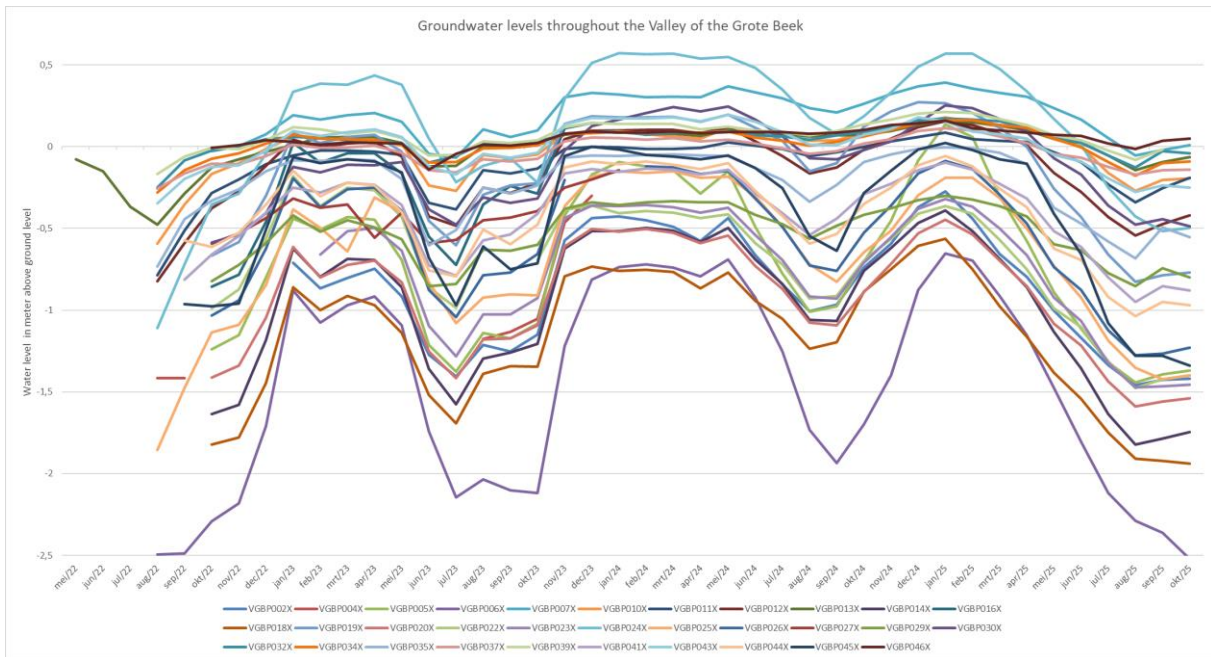
Figure 4: water levels in the Grote Beek Valley. Although not so clear on the graph because of the very dry period after rewetting, we can see the effects of rewetting slightly by looking at the highest water levels. One can see a steady increase in the highest water level for most of the locations equipped

with water level loggers. The loggers are installed throughout the valley, so also on the flanks. Deeper water level can thus be expected for some of these.

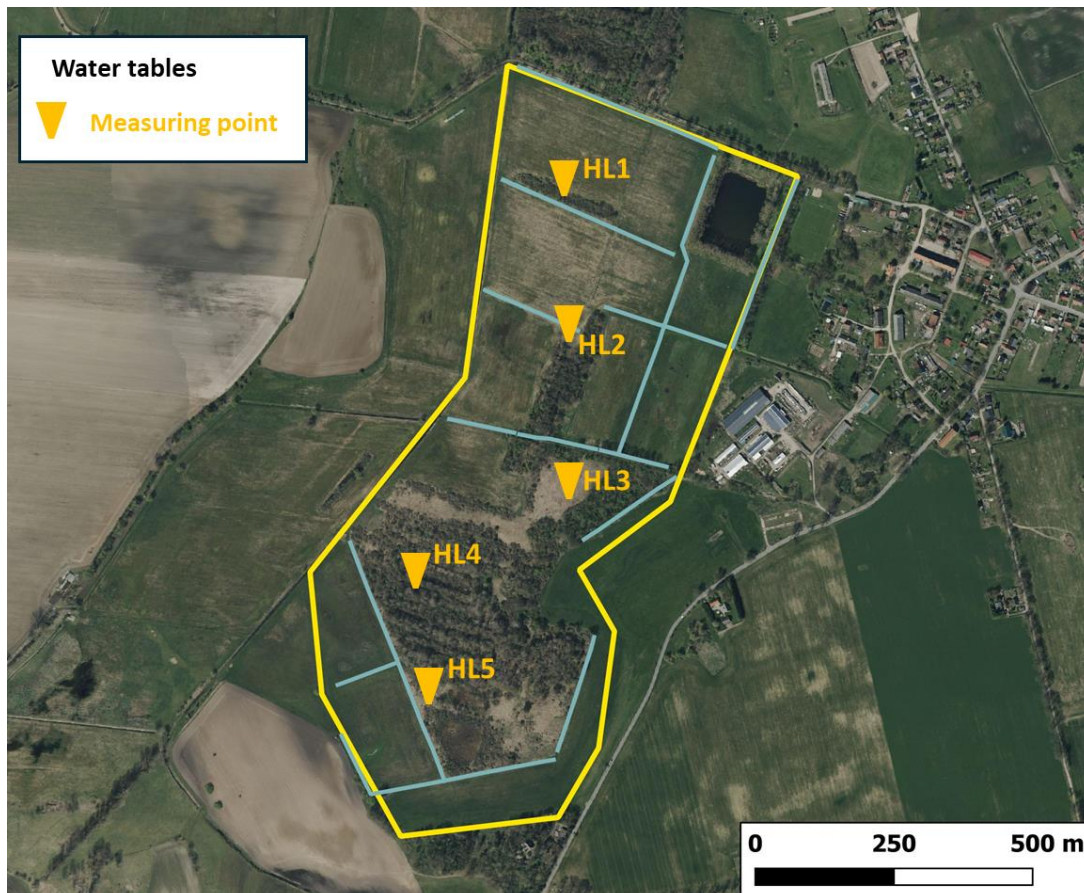
Figure 8: Positions of the water loggers at the project site in October 2022

Hydrological equipment was installed at the monitoring site at two different points of time. Five water loggers (Device: Meter “Hydros 21”) HL\_01 to HL\_05 were installed in October 2022 (see Figure 8). Six more sensors working with wireless data transmission (Device: MMM-tech “RKL-01-5”) PSSS01 to PSSS03 and PSGW01 to PSGW03 were installed in June and July 2023 to monitor the “test rewetting” (Figure 10). The test rewetting refers to the reactivation of three old weir facilities to prove their effectiveness and build trust with local farmers. It started in June 2023 and is ongoing. The sensors named PSSS are directly implemented in the weirs and the sensors named PSGW were installed in the field in position, which supposedly are affected by a rise of the water levels in the respective ditches (see Figure 11).

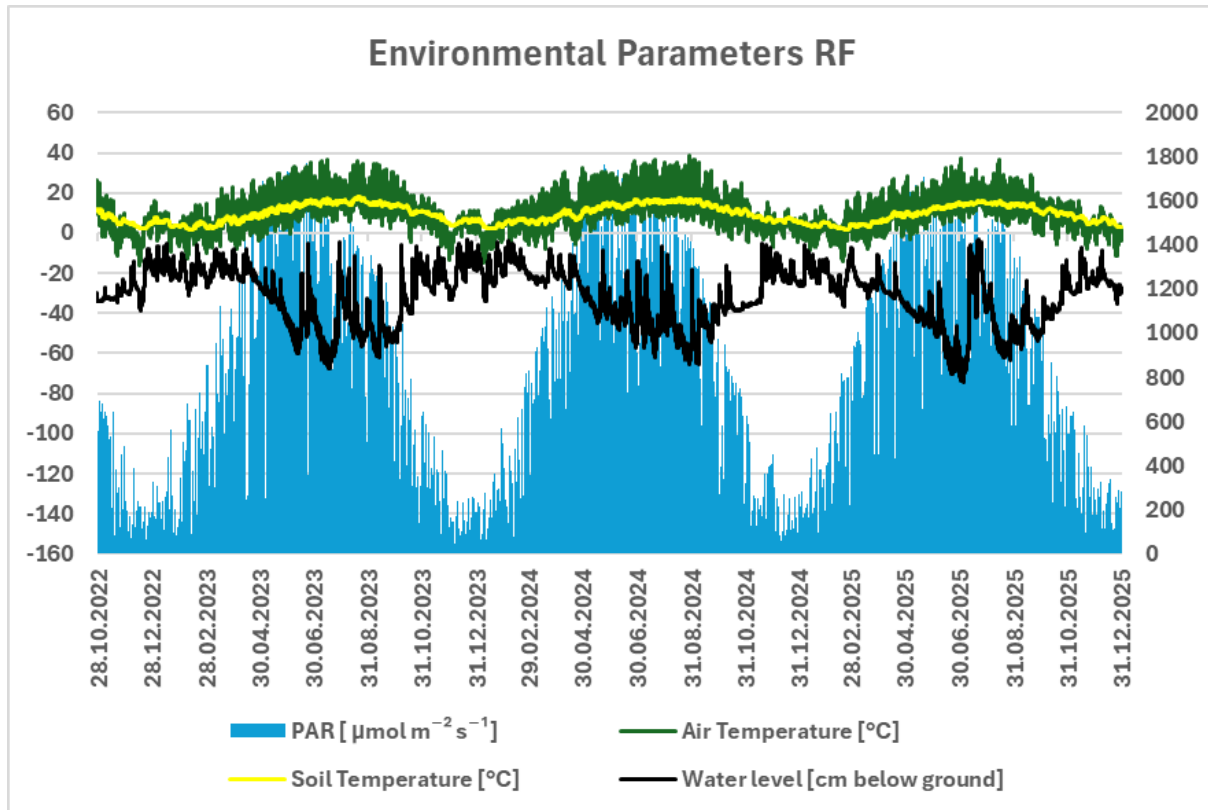
Figure 15: Environmental parameters at GHG-measuring site of the reference peatland Rüdritzer Fließ.

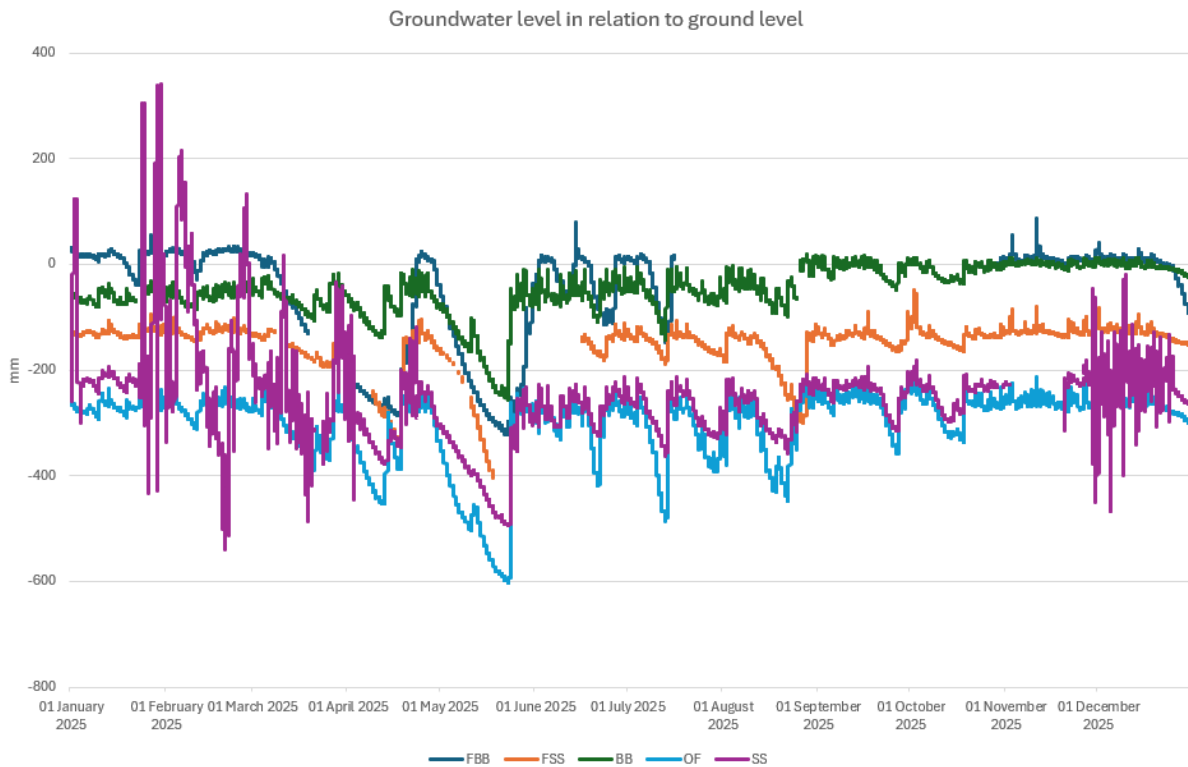
Figure 22: Groundwater level across monitoring stations during the 2025 monitoring period.

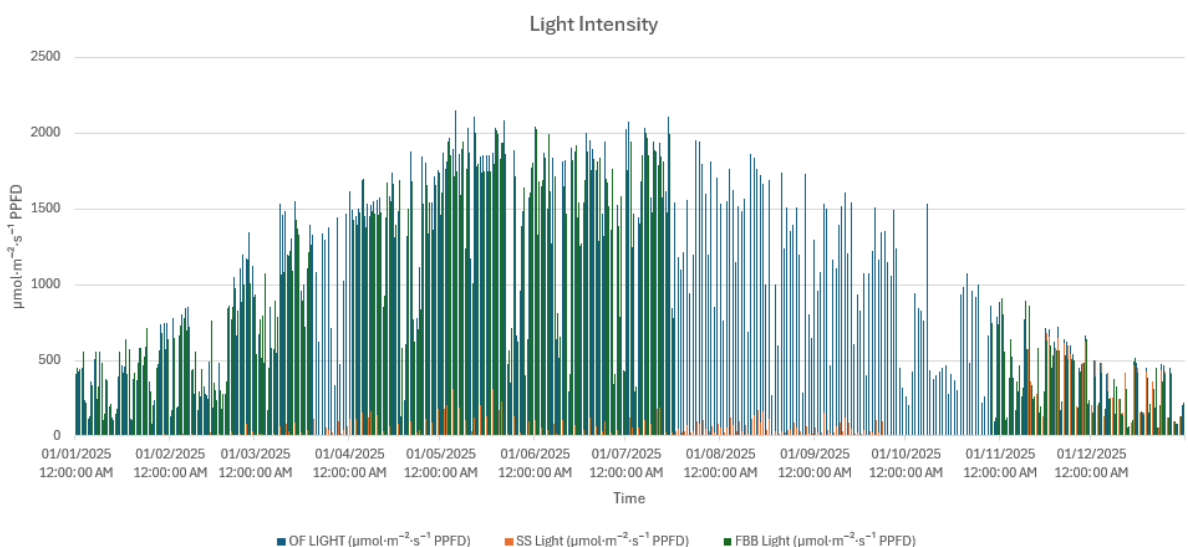
Figure 23: Light intensity measurements at Dore Fhada during the 2025 monitoring period.

Light intensity at each ecotope was monitored continuously throughout 2025 with data logged every 15 minutes (Figure 23). At the Sitka Spruce station light intensity for most of the year was much less than other ecotopes, due to shading by the trees. From November light intensity at Sitka Spruce increases due to felling works associated with restoration.

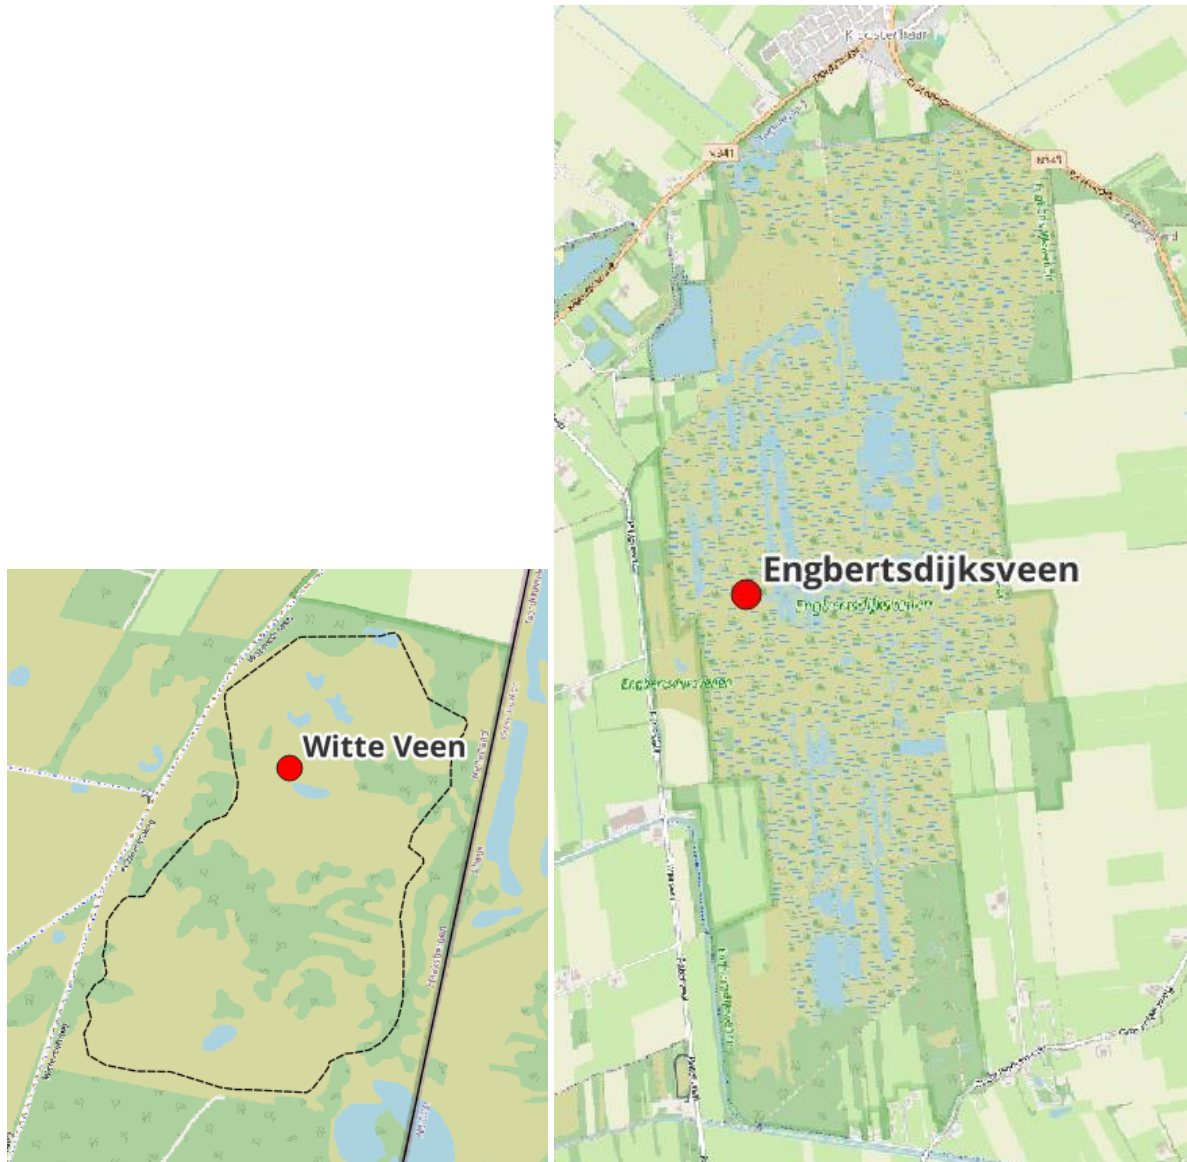
Figure 31: Location of the GHG measurements (center of the plots) and the additional piezometers within the two sites.

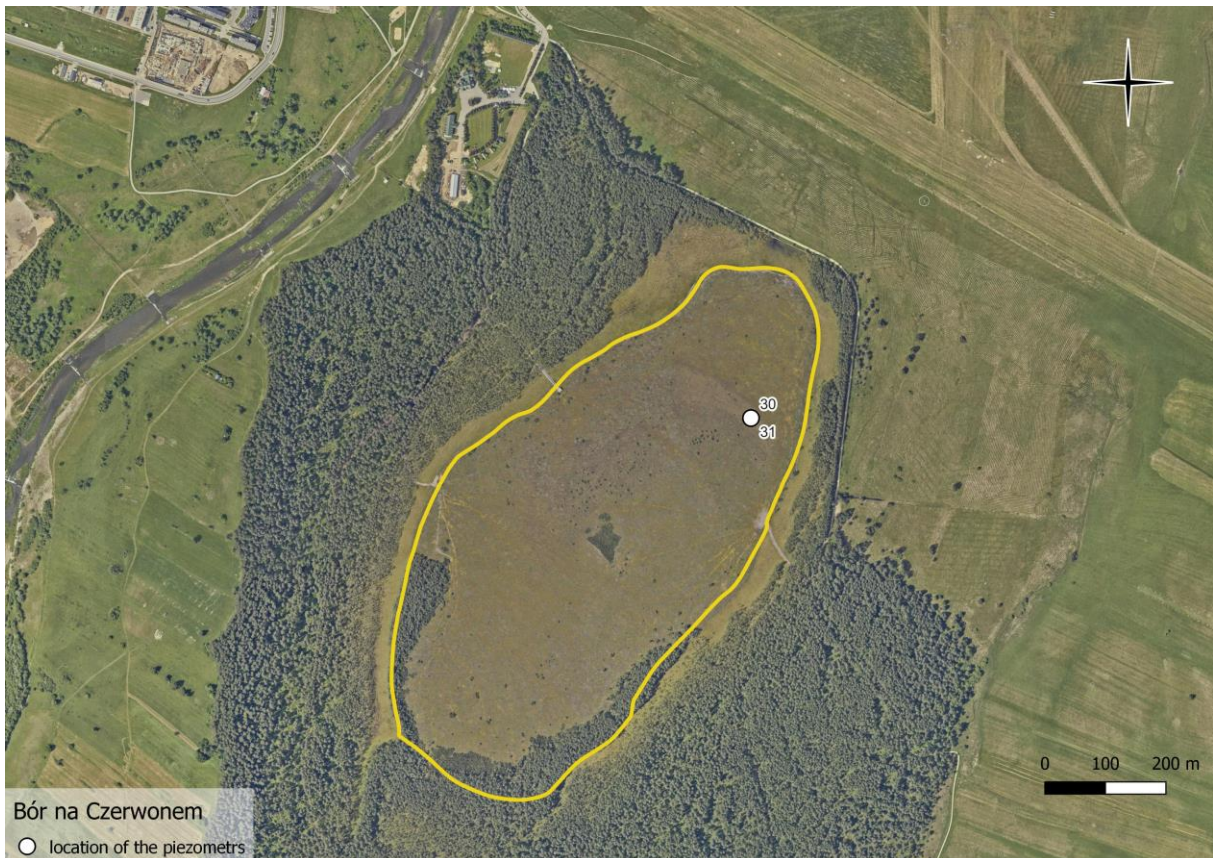
Figure 51: Location of piezometers at Bór na Czerwonem site

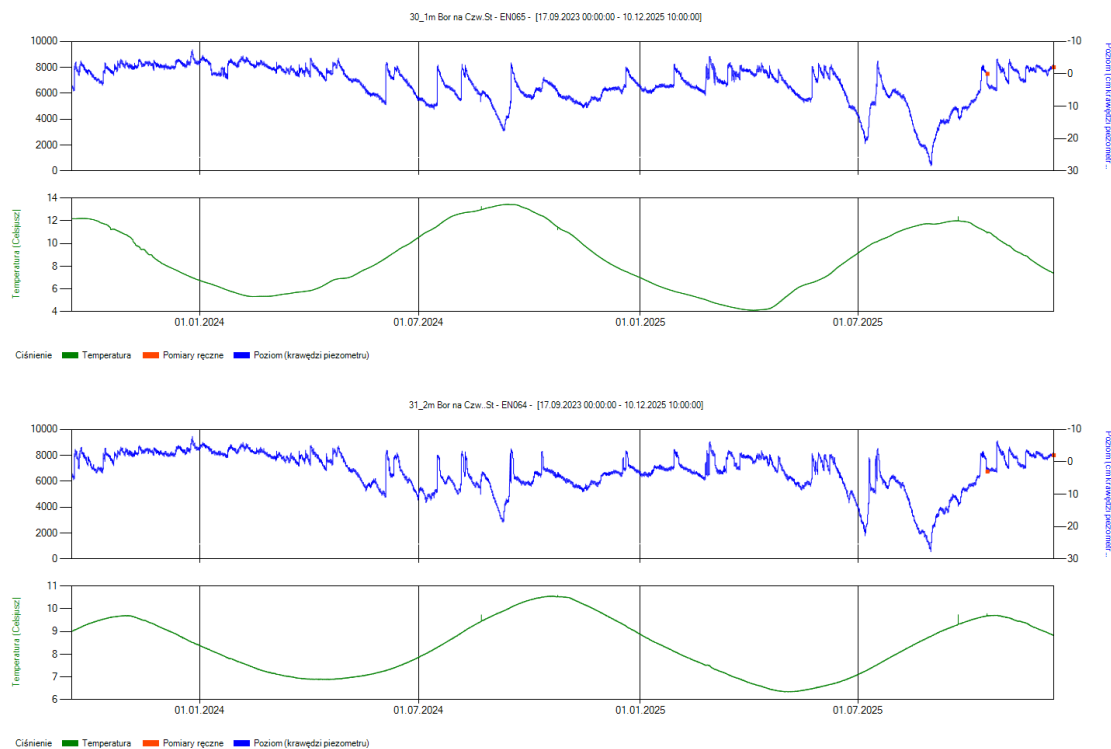
Figure 52: Water table measurements at Bór na Czerwonym site

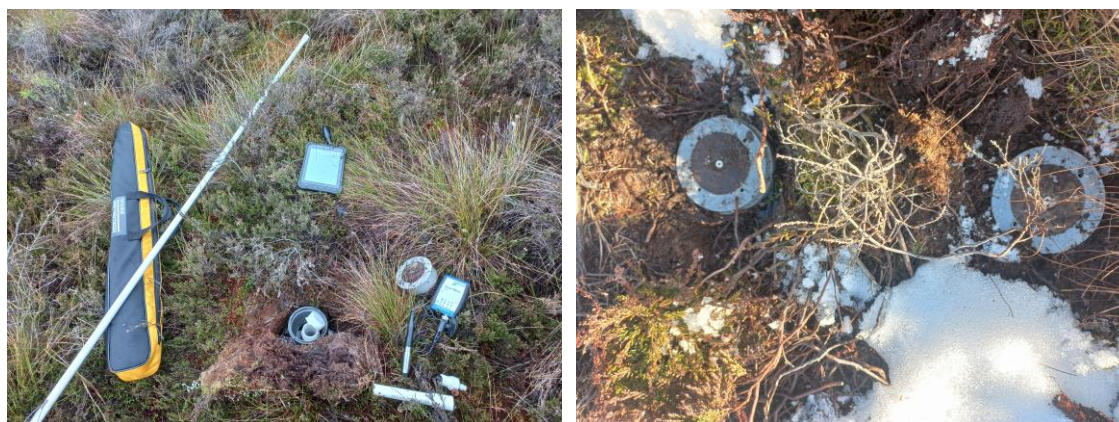
Figure 53: Field measurements (calibration) of water tables (left); installation of piezometers with lockable caps (right)

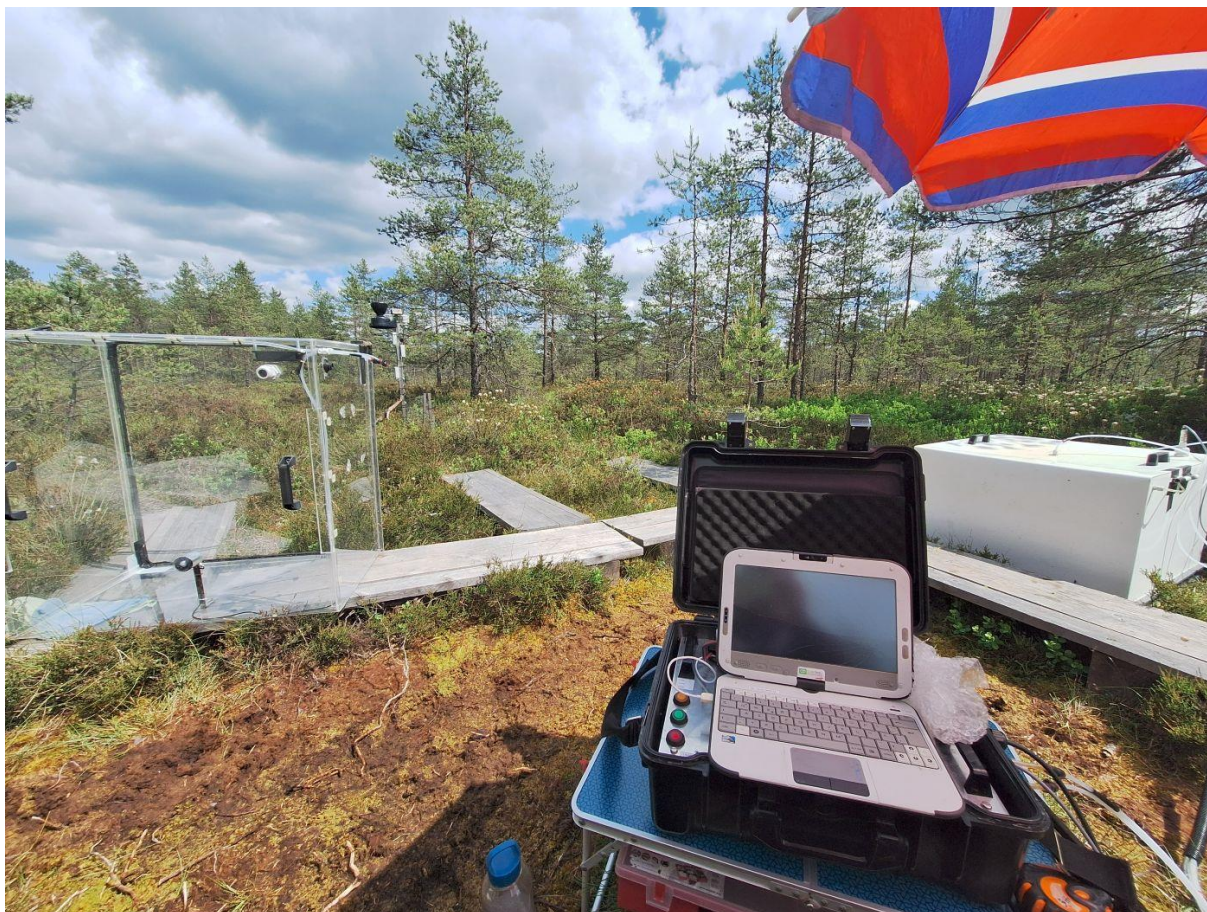
Figure 57: GHG measurement at Puszczna Mała (Orawa 2) site, July 2025. Photo: T. Wilk
